QA-249
Barbadoes Hall
Centreville vicinity
Private

MARYLAND HISTORICAL TRUST

INVENTORY FORM FOR STATE HISTORIC SITES SURVEY

Barbadoes Hall, Barbathos Hall

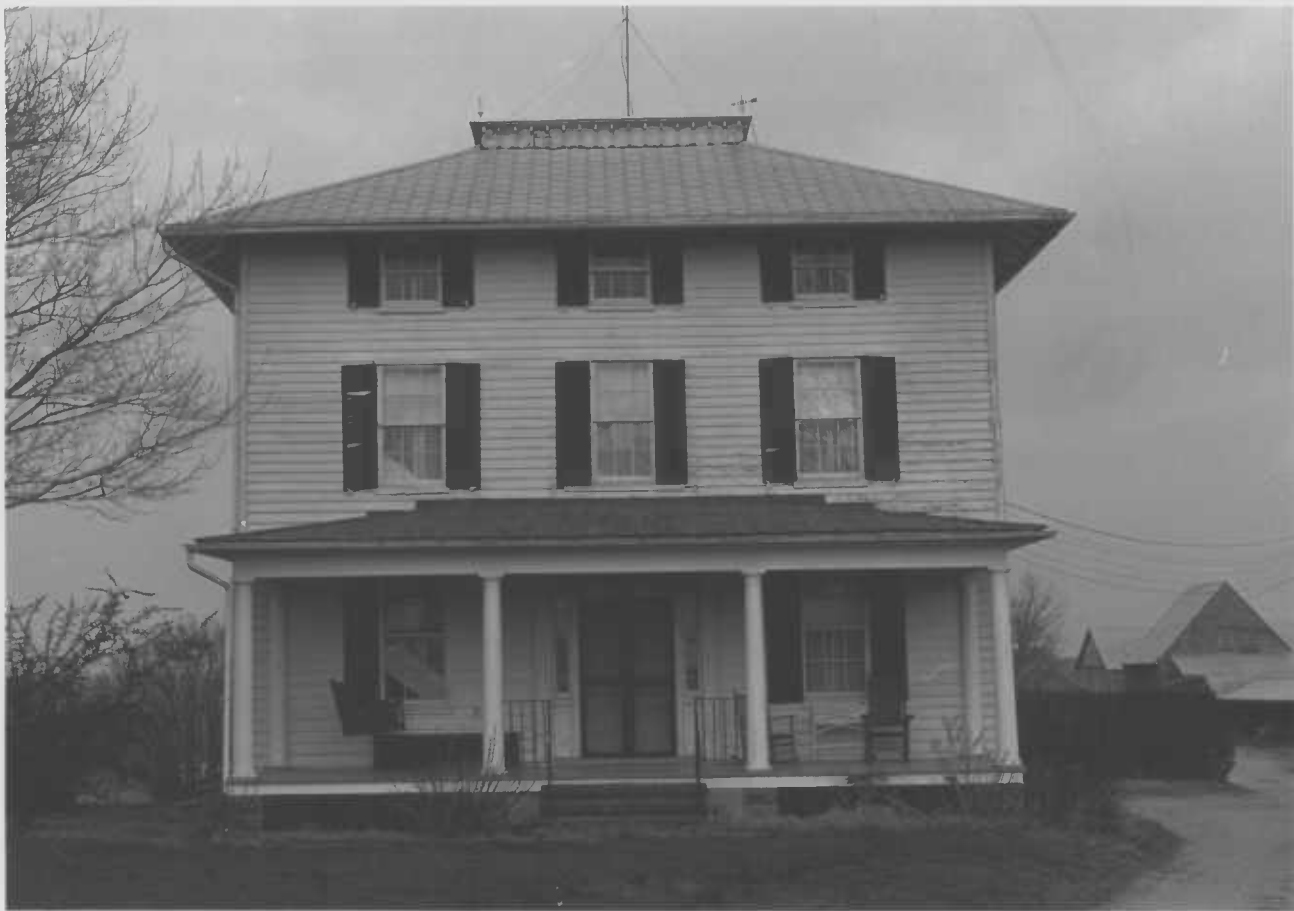
QA-249

Claude Anthony Farm
Centreville Vicinity
Orlando Ridout V 1979 (MHT)
Front facade, from SW

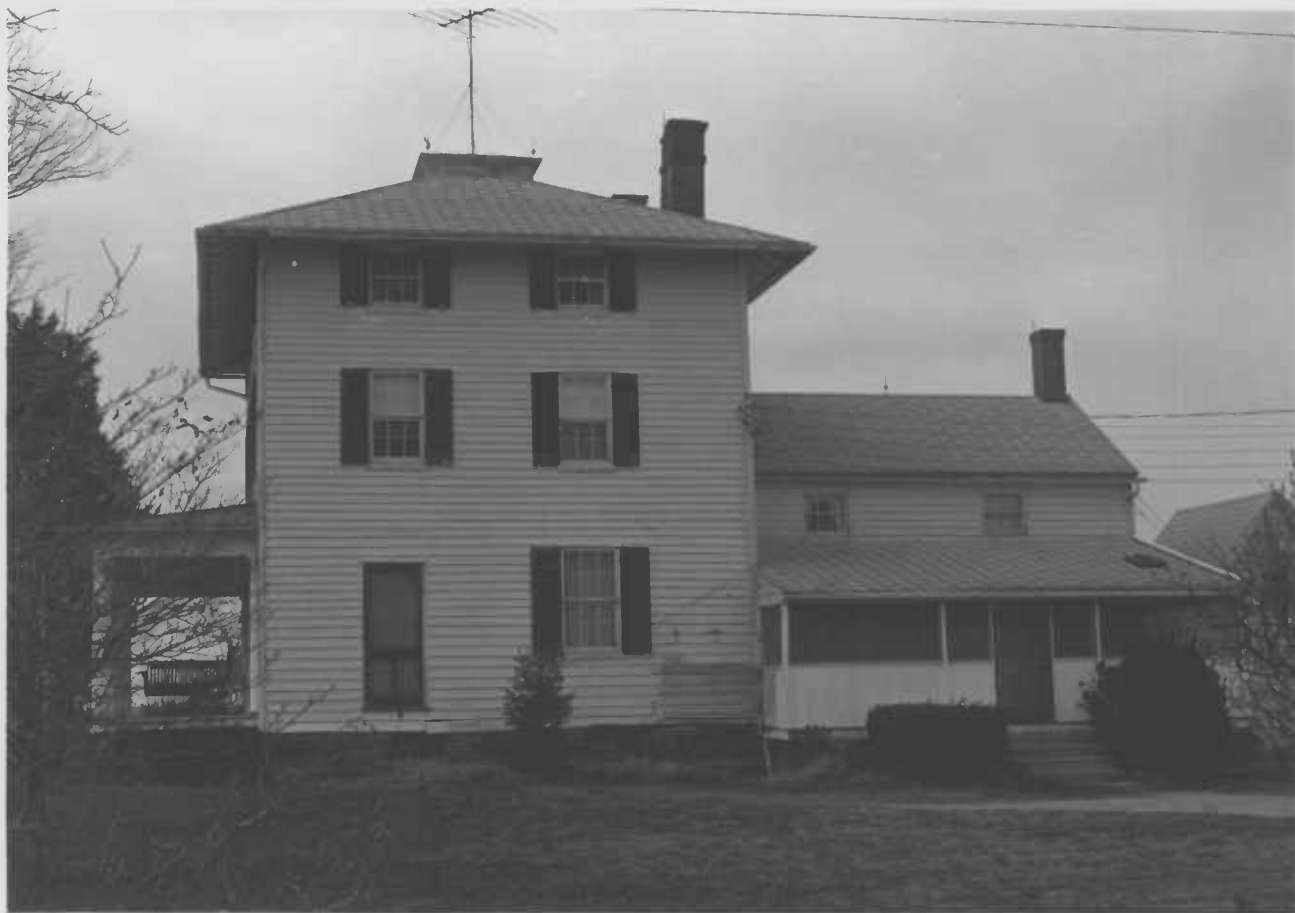
QA-249

Orlando Ridout V 1979 (MHT)
SE facade

The south facade is similar to the north facade, with the addition of two three-light cellar windows. A fieldstone foundation below the brick foundation is visible on this side.

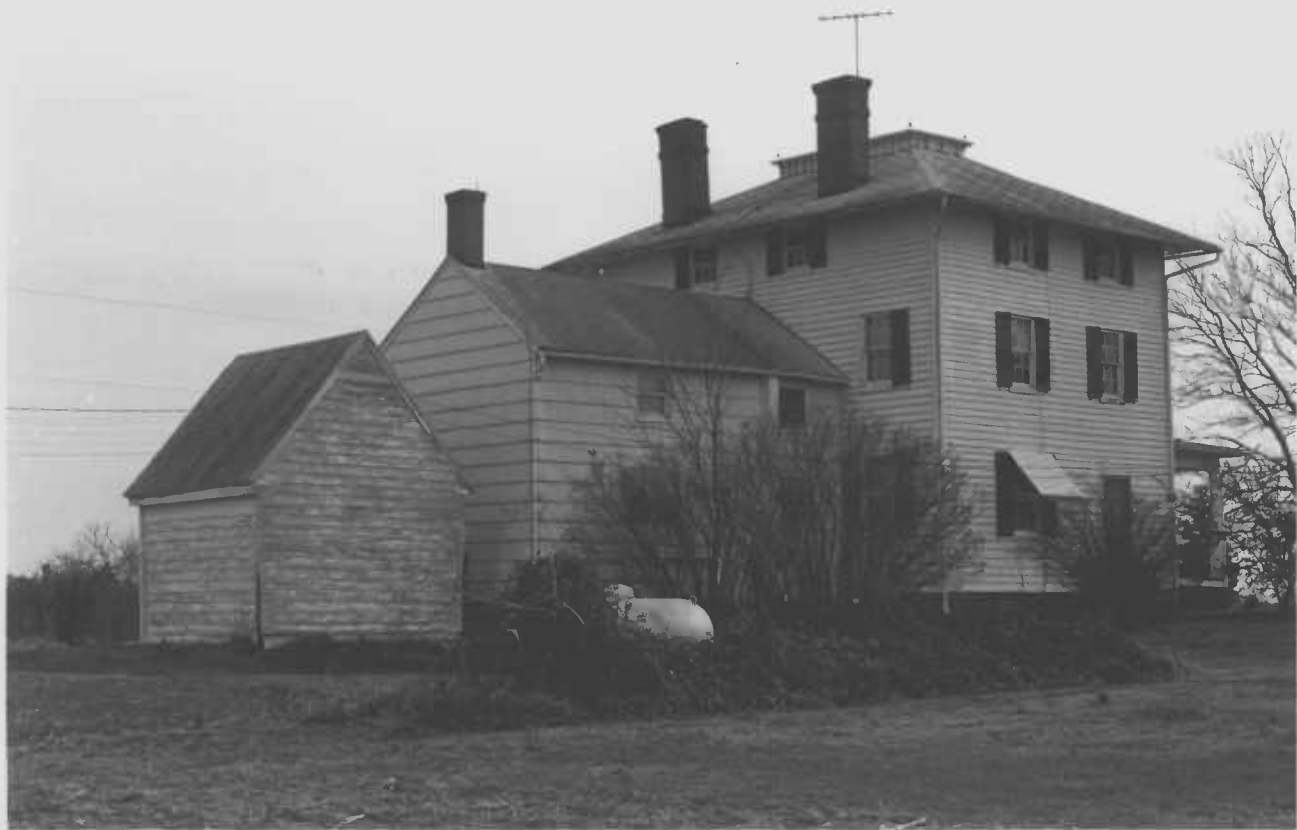
QA-249

Claude Anthony Farm
Centreville Vicinity
Orlando Ridout V 1979 (MHT)
View from north

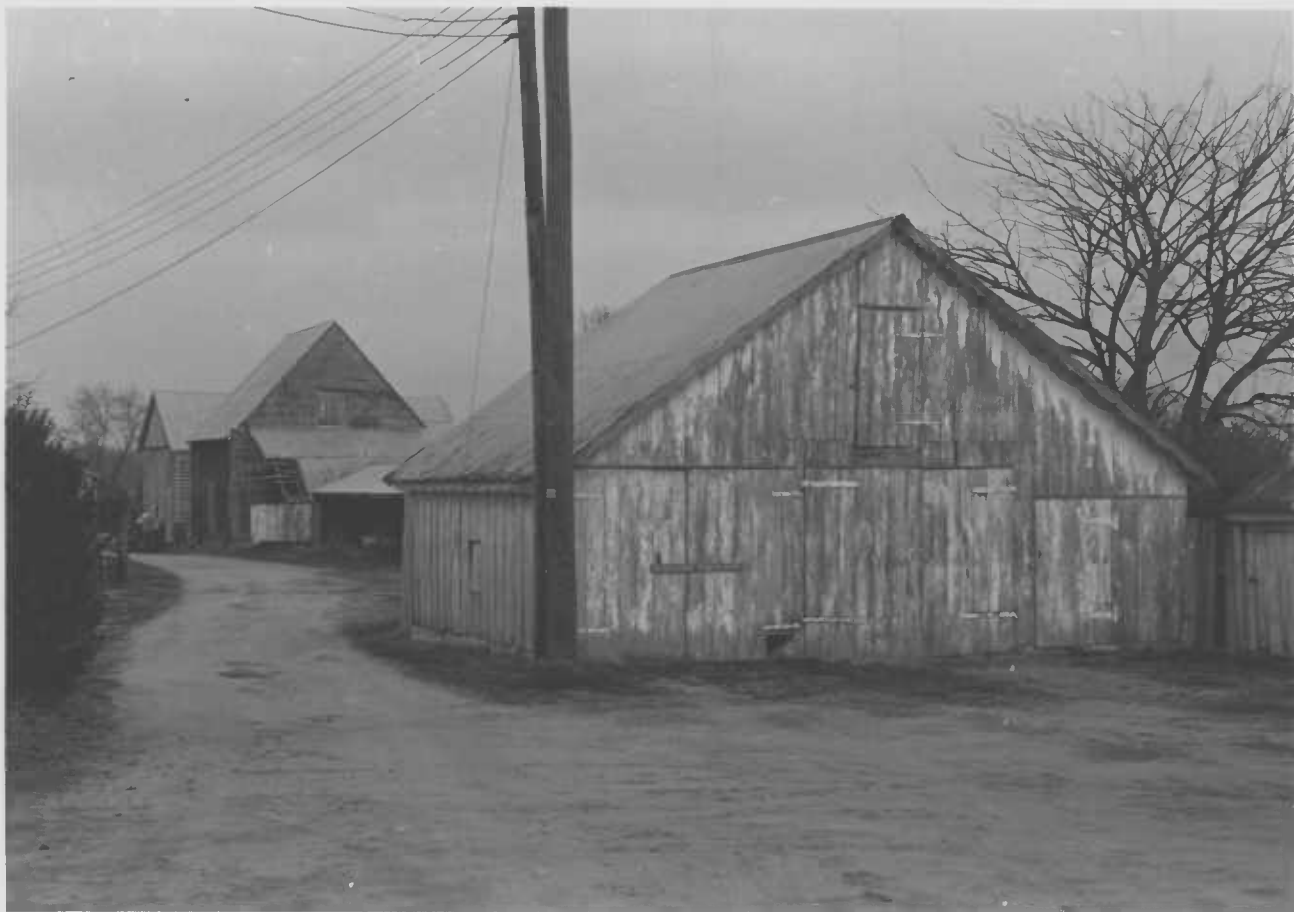
QA-249

Claude Anthony Farm
Centreville Vicinity
Orlando Ridout V 1979 (MHT)
Farm Building
